CIVIL AERONAUTICS BOARD

AIRCRAFT ACCIDENT REPORT

AMERICAN AIRLINES, INC., BOEING 707-123B
N 7506A, JAMAICA BAY, LONG ISLAND, NEW YORK,
MARCH 1, 1962

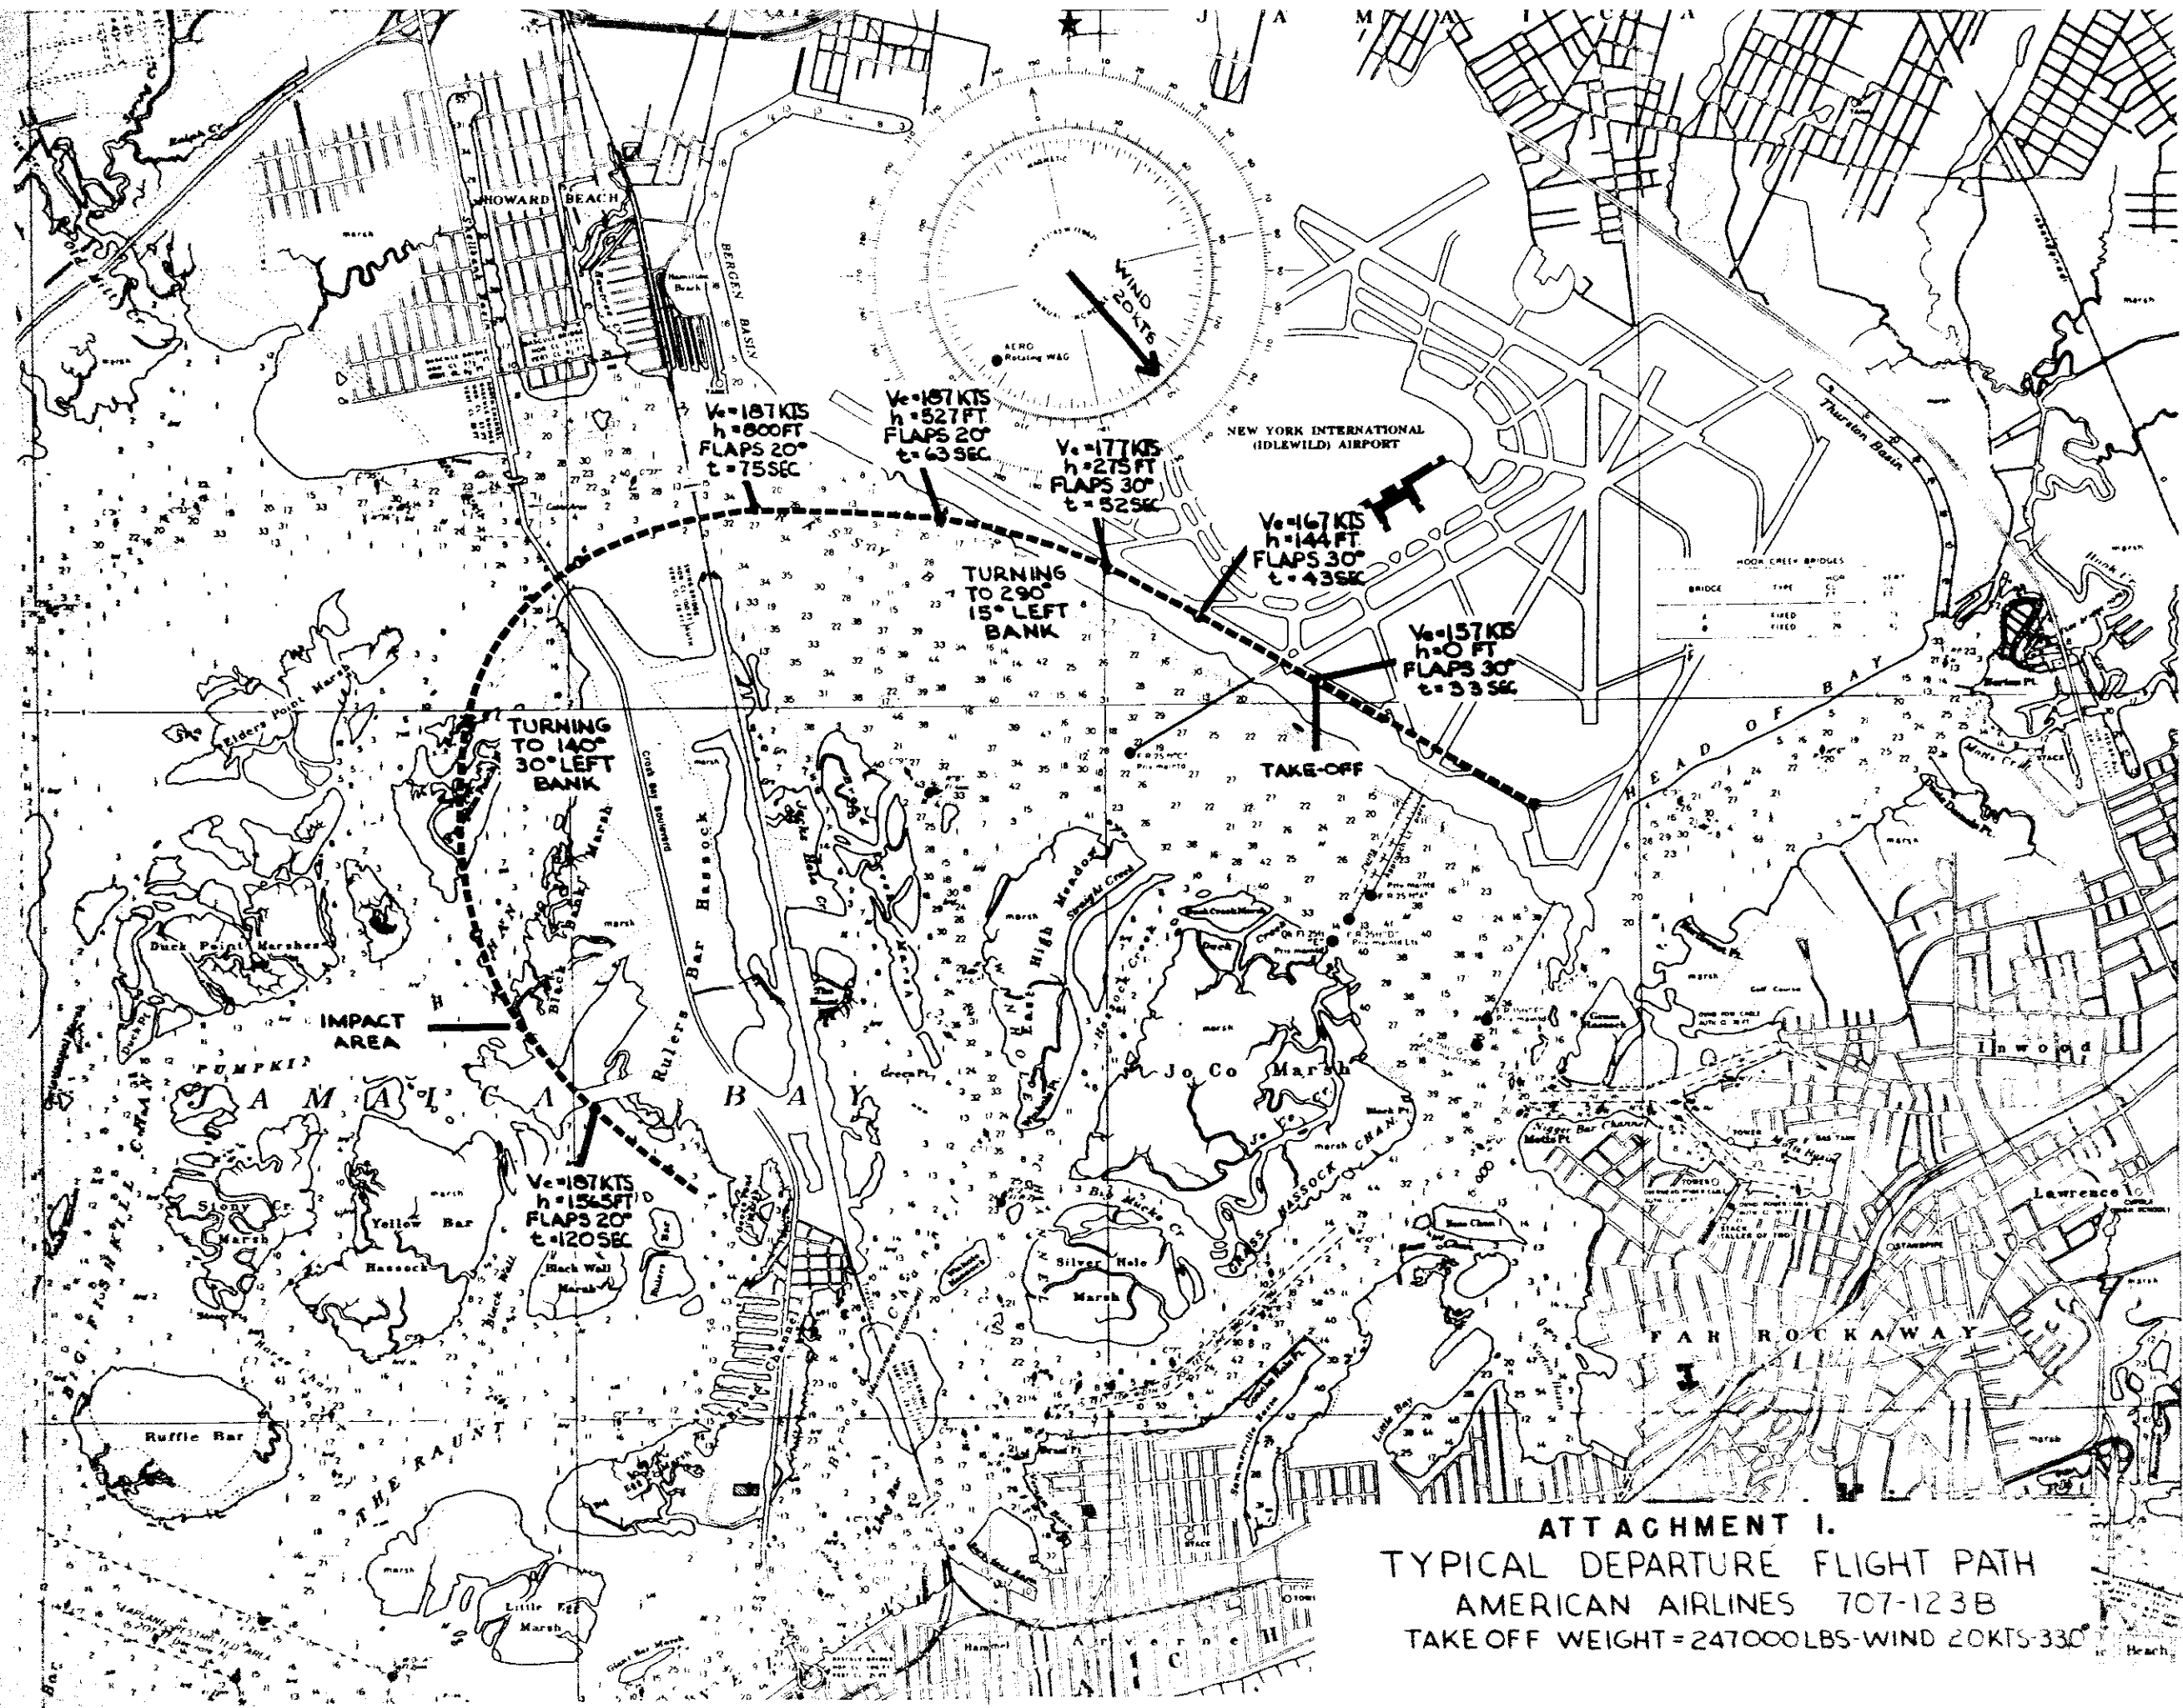
CIVIL AERONAUTICS BOARD FLIGHT RECORDER DATA

Returning to consideration of the second left turn, the heading change becomes slightly wavering from 1008:01 to 1008:07, and in the turn the heading changed from 273 to 250 degrees, averaging a rate of 3.83 degrees/second. Damage to this area of the flight recorder foil produced a slight displacement and rotation with the result that the heading change rate indicated is probably higher than actual. However, the difference is so small as to be of negligible importance in this discussion. With the airspeed increasing from 193 to 198 knots at the same time, the bank angle would be about 35 degrees and the increase in normal load factor due to the turn would be about 0.2 g in a coordinated turn.

At 1008:07, within six-tenths of a second, a heading change from 250 to 243 degrees is recorded; a change rate of 12 degrees/second, amounting to an instantaneous tripling of the 3.83 degrees/second change rate recorded just prior to this time. From 1008:08 to 1008:16 the heading trace passes through the badly wrinkled, abraded and torn portion of the foil, during which time the heading changed from 245 to 225 degrees. At time 1008:16, the heading trace emerges from the badly damaged portion of the foil and for the next one and one-half seconds indicates a much lower rate of heading change than that immediately preceding entry into the damaged area. The heading trace shows a momentary cessation of turn at 1008:19 followed by a higher turn rate continuing until 1008:31, when a sharp reversal in the recorded heading is noted. Such an abrupt change from a left turn to a right turn is beyond the aircraft's capability and is an indication of gimbal error in the directional gyro of the airplane as the angle of left bank approached 90 degrees. From this time to about 1008:42 the recorded headings are similarly in error due to the high roll and pitch angles of the airplane as it inverted and dove to the ground.

At time 1008:18, 1008:25 and 1008:29 the airspeed and altitude traces indicate sharp simultaneous increases which were beyond the aircraft's performance capability, and the highest peaks recorded indicate an airspeed of 230 knots and 2,000 feet of altitude at 1008:30. The precise significance of these recordings cannot be completely defined. However, a single static port low on the left side of the forward fuselage is connected to the airspeed and altitude sensors of the flight recorder. As a result, nose left sideslip (relative wind from the right) and high angles of attack cause appreciable plus errors in the recorded airspeed and altitude.
